SHEILE PRIMARY SCHOOL
DAHUK, IRAQ

SIGIR PA-06-038
APRIL 5, 2006

SUBJECT: Report on Project Assessment of the Sheile Primary School in Dahuk, Iraq
(Report Number SIGIR-PA-06-038)

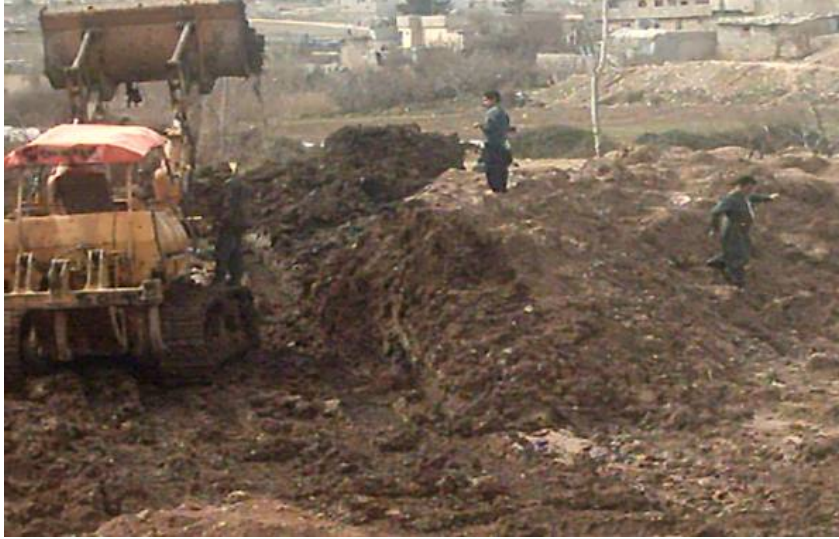
The school is being built on a vacant lot that was donated by the Dahuk Governorate. The land was previously used as a small agriculture site and required grading, removing unsuitable soil, excavation, and trenching around the school boundary. Based on the GRN site reports, groundwater in the area was high and required a filter layer to divert the flow of the ground water under the school building. Soil testing was completed to determine the type of soil at a depth of three meters and remove unsuitable material. Site Photo 1, taken from the USACE February 19, 2005, Quality Assurance Report, shows the early site preparation work.

Site Photo 1. Initial site preparation work – Photo provided by USACE

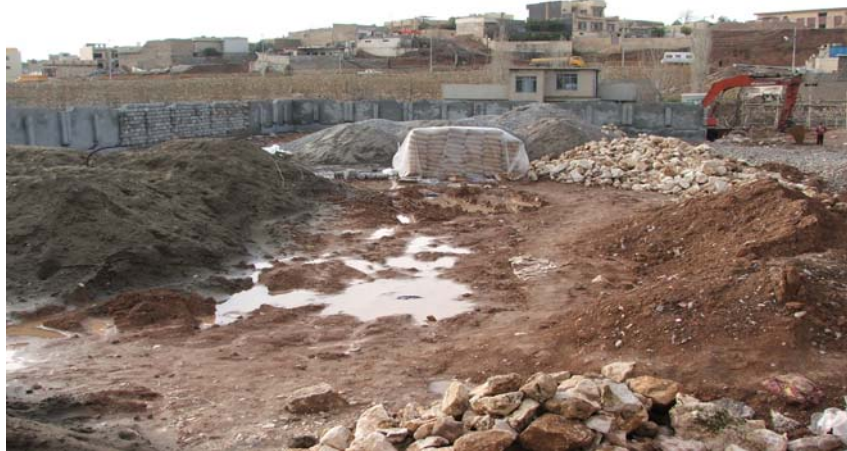
At the time of our assessment, site preparation for the buildings was completed. The garden areas in front of the school and the play yard were still being used as a staging area for construction materials and had not been completed. Site Photo 2 shows the condition of the garden area (with the play yard in the background) at the time of the assessment.

Site Photo 2. Garden area at the time of the assessment on January 24, 2006.

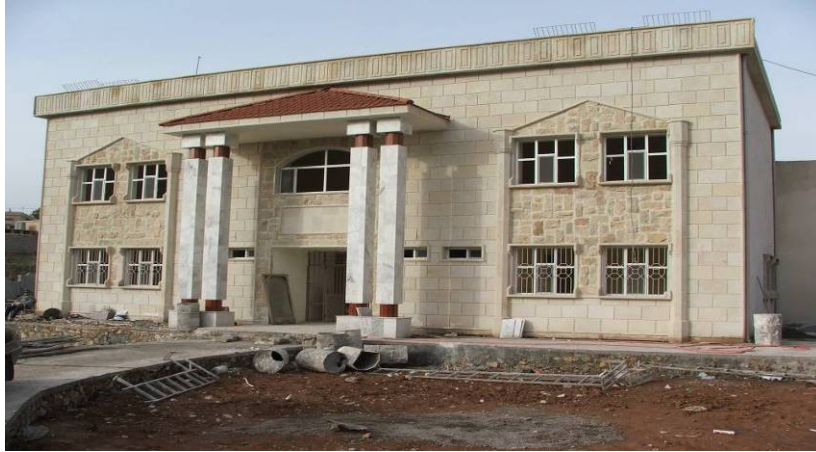
Construction of the main school building and the auxiliary buildings was completed and included installation of the plumbing, electrical circuitry, and fixtures. Tiling inside both buildings was completed along with painting, both inside and outside. Window frames were installed throughout and glass was partially installed. Touchup painting was underway on both buildings. Site Photo 3 shows the completed work on the front exterior of the building at the time of the assessment.

Site Photo 3: Front of the building at the time of the assessment

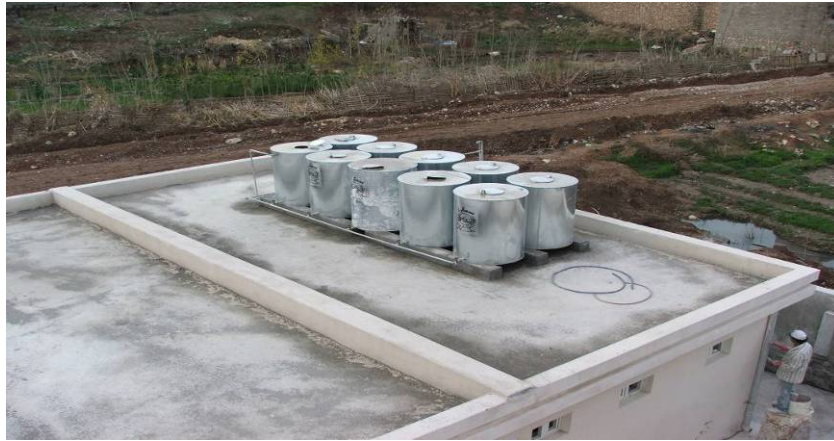
Water tanks, plumbing, electrical circuitry, and associated fixtures were installed but not yet operational because the electricity had not been connected. Ten water tanks were installed on the top of the auxiliary building and connected to the main water supply from the city (Site Photo 4). Six eastern style toilets were installed in both the girl's and boy's restrooms and four faucet handwash areas were installed outside each restroom. Three additional water tanks, also connected to the city water supply, were installed on the roof of the main building to provide service to the faculty restrooms. The men's and women's restrooms are furnished with two water closets each. Ceiling fans and lights were installed in each room. Site Photo 5 shows the handwash areas outside the boy's bathroom in the auxiliary building.

Photo 4. Water tanks installed on roof of the auxiliary building

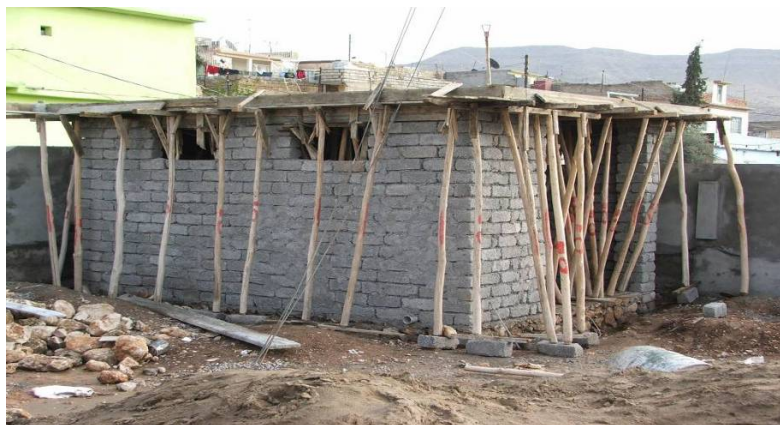
Construction of the generator building was underway at the time of our assessment. The foundation, concrete floor, and cinderblock walls were completed and the concrete roof construction was in progress. Site Photo 9 shows the generator building at the time of the assessment.

Site Photo 9. Generator building

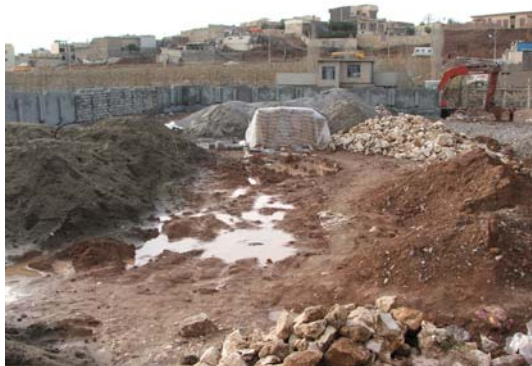
The play yard and garden were still being excavated at the time of our assessment. The area was being used as a material staging area. Site Photos 10 and 11 show the garden and play yard status respectively.

Site Photo 10. Garden area location

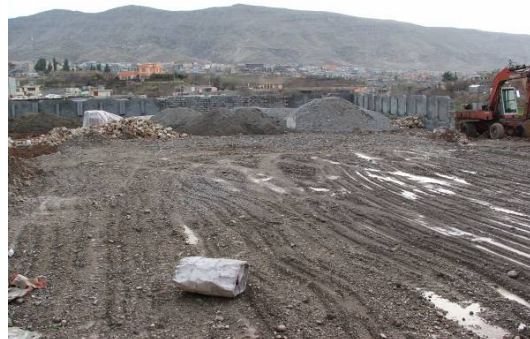
Site Photo 11. Play yard area site location
